Road & Railroad Crossing Inventory Mauvais & Big Coulee

**Bureau of Reclamation
Dakotas Area Office**

September 1999

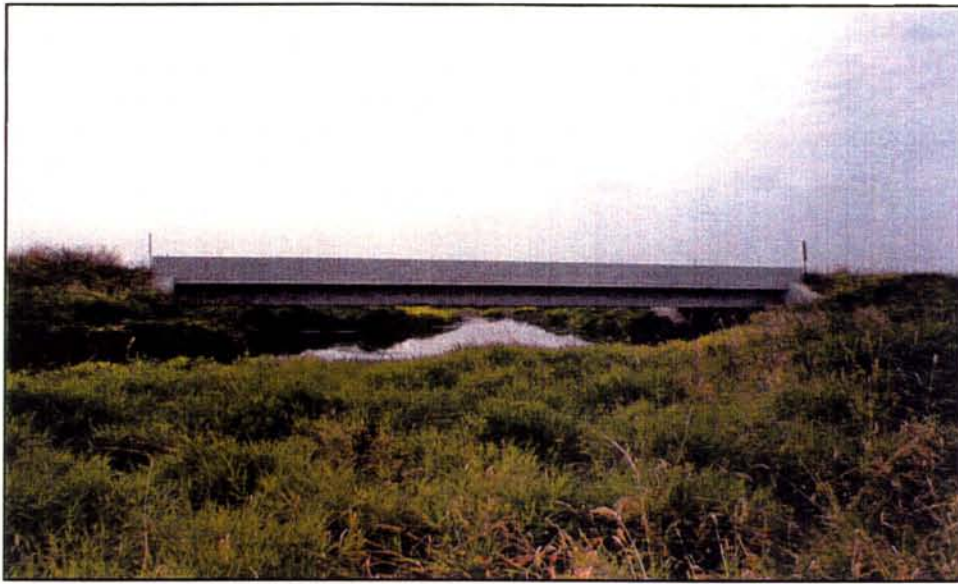
M1 Upstream side of concrete bridge on Maza road, in good condition,
Section 36 & 2, T157 & 156N, R66W, N 503009.91, E 2338124.55,
Elevation 1438.2 @ ∇ of coulee.

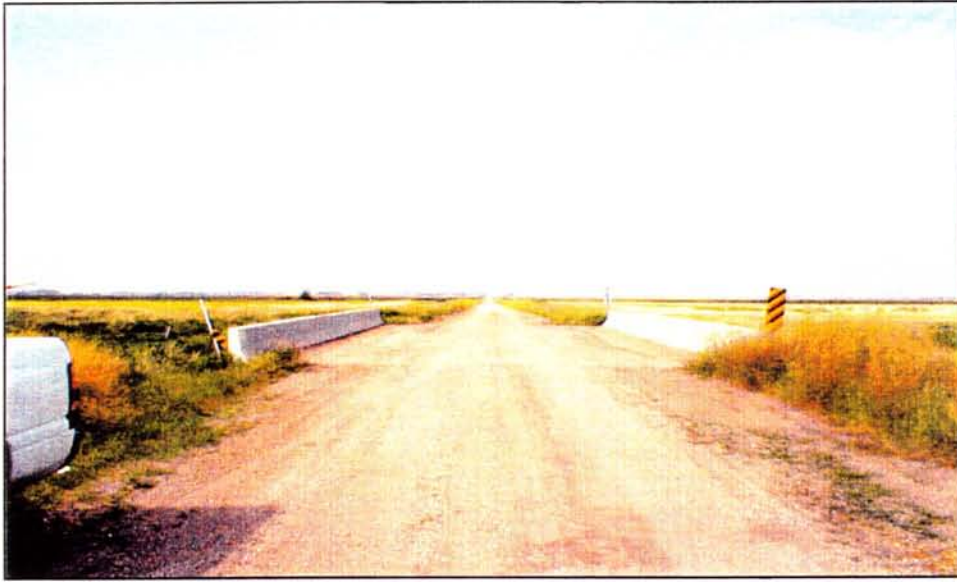
M1 Center of concrete bridge on Maza road, in good condition, 30.0' wide & 72.0' long, Section 36 & 2, T157 & 156N, R66W, N 502994.78 E 2338124.66, Elevation 1452.9 @ center of bridge.

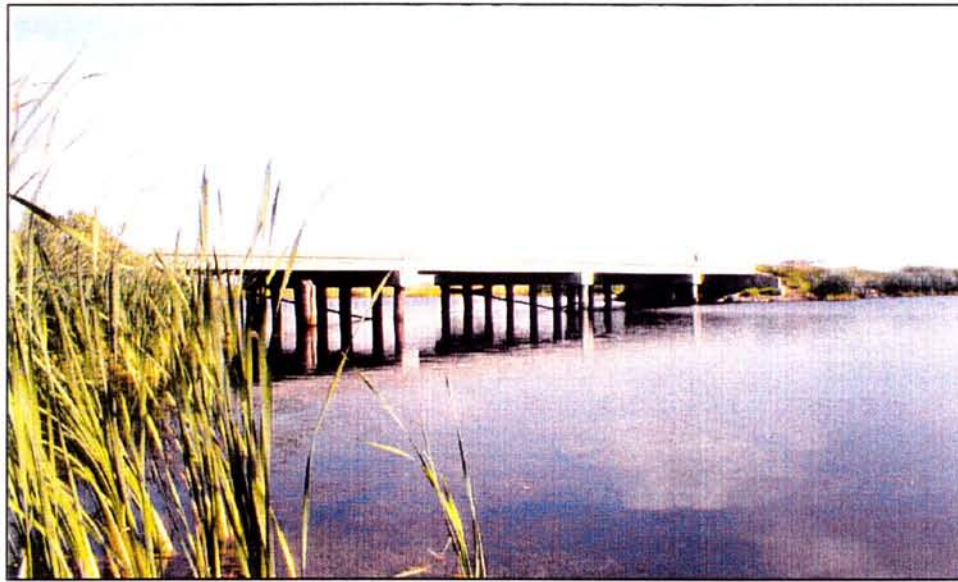
M2 Downstream side of concrete bridge, in fair condition, 7.7 feet of water (8-11-98), Section 25 & 36, T157N, R66W, N 508259.25, E 2337598.51, Elevation 1436.9 @ ∇ of Coulee.

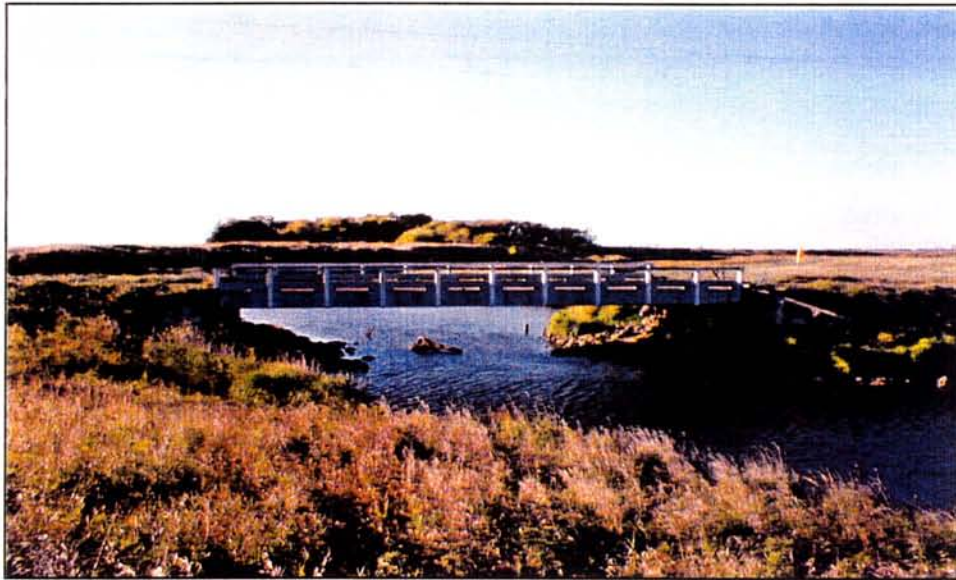
M3 Upstream side of concrete bridge, in good condition, 7.0 feet of water (9-30-98), Section 7 & 18, T157N, R65W, N 524176.01, E 2340888.12, Elevation 1438.6 @ Φ of coulee.

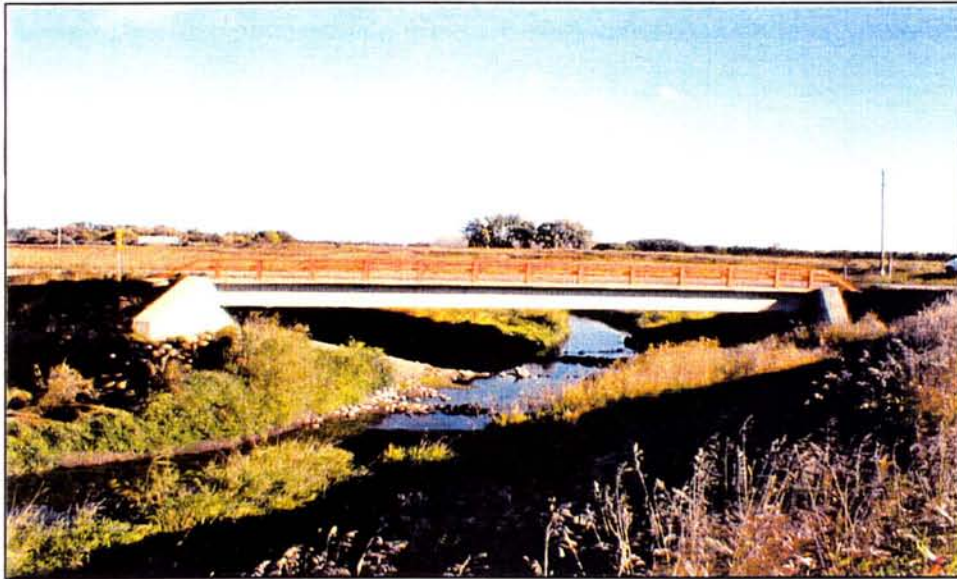
M4 Downstream side of concrete bridge, in good condition, 1.0 foot of water, (9-30-98), Section 6 & 7, T157N, R65W, N 529415.68, E 2339960.63, Elevation 1444.2 @ \perp of coulee.

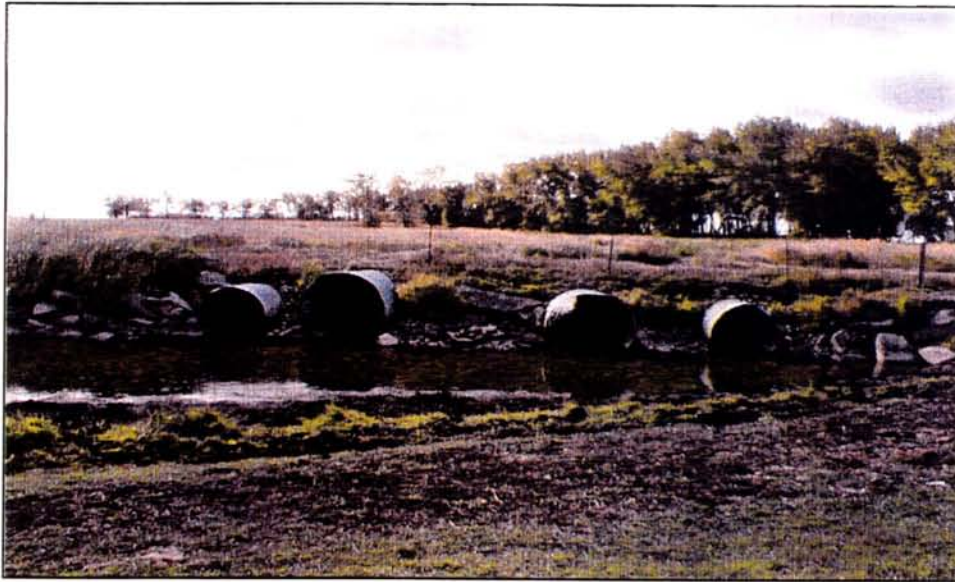
M5 Upstream side of four 72" CMP's, in good condition, 0.5 foot of water (9-30-98), Section 30 & 31, T158N, R65W, east to west N & E,
 N 540047.07, E 2340752.70, Elevation 1453.3 @ invert of CMP,
 N 540047.67, E 2340744.94, Elevation 1453.6 @ invert of CMP,
 N 540048.75, E 2340728.62, Elevation 1452.6 @ invert of CMP,
 N 540049.17, E 2340718.25, Elevation 1453.1 @ invert of CMP.

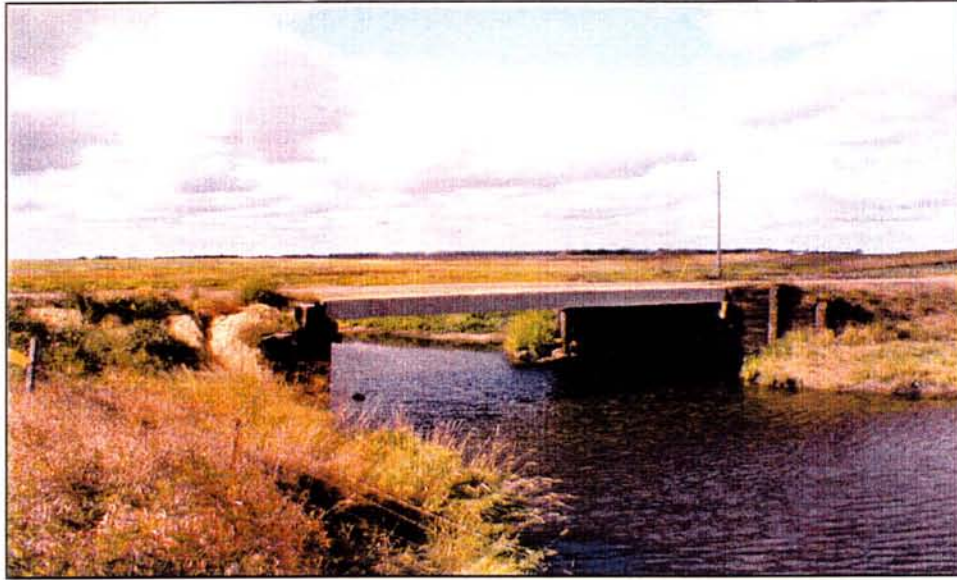
M6 Downstream side of concrete & wood bridge, in fair condition, 6.0 feet of water (9-30-98), Section 25 & 30, T158N, R65 & 66W, N 542470.54, E 2339445.34, Elevation 1449.5 @ ∇ of coulee.

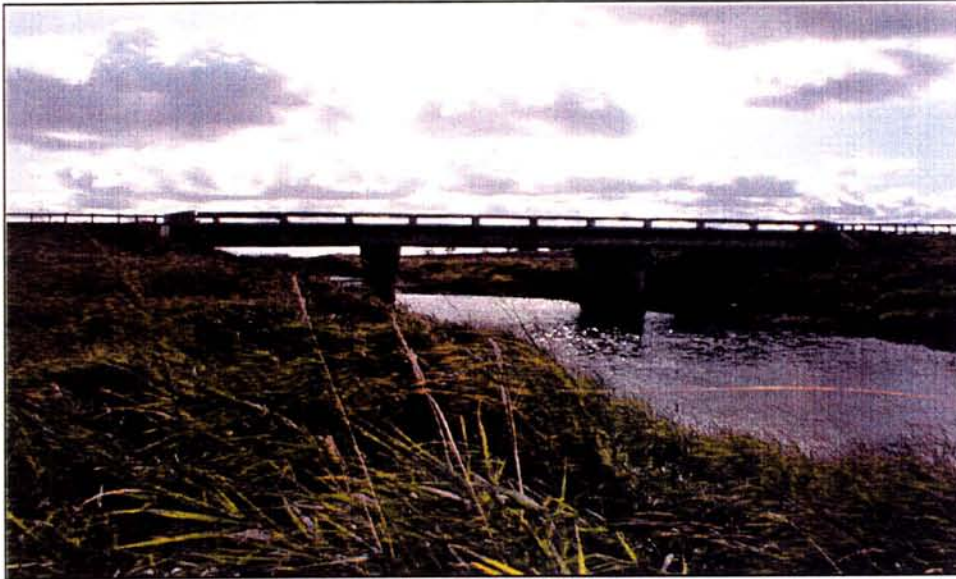
M7 Upstream side of concrete bridge on N.D. Hwy. 17, in good condition, 4.6 feet of water (9-30-98), Section 24 & 25, T158N. R66W, N 545264.79, E 2336722.34, Elevation 1451.1 @ center of bridge.

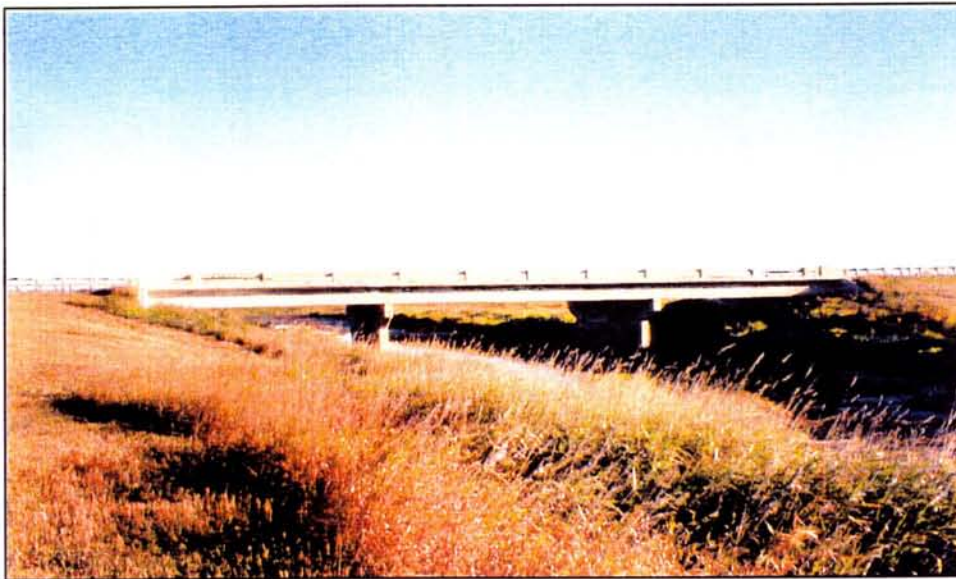
M7 Downstream side of concrete bridge on N.D. Hwy. 17, in good condition, 3.9 feet of water (9-30-98), Section 24 & 25, T158N, R66W, N 545229.41, E 2336723.85, Elevation 1451.8 @ center of bridge.

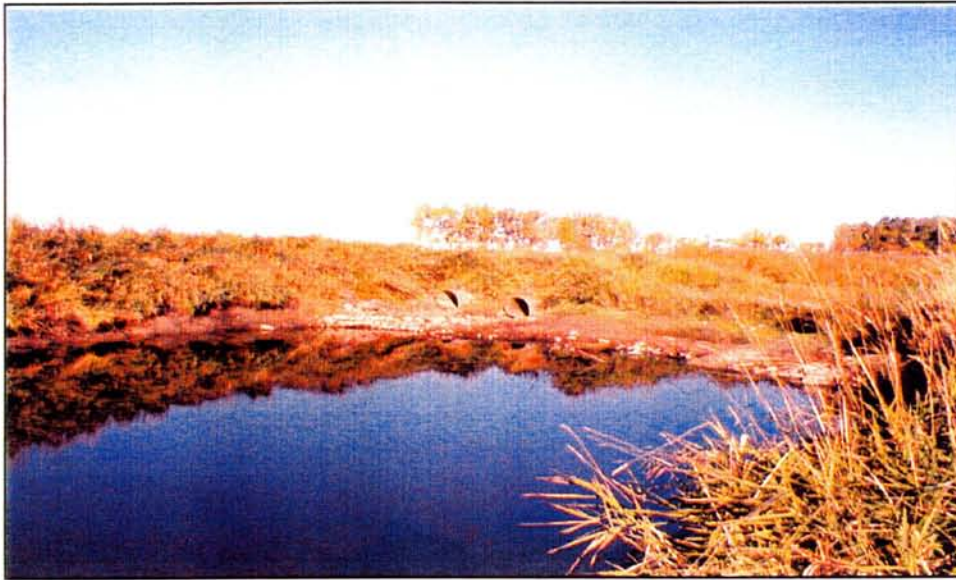
M8 Downstream side of two 30" x 42" CMP's, in good condition, no water, (10-1-98), Section 13 & 24, T158N, R66W, N 550482.49, E 2334612.12, Elevation 1457.9 @ invert of east CMP, N 550481.13, E 2334602.44, Elevation 1458.2 @ invert of west CMP.

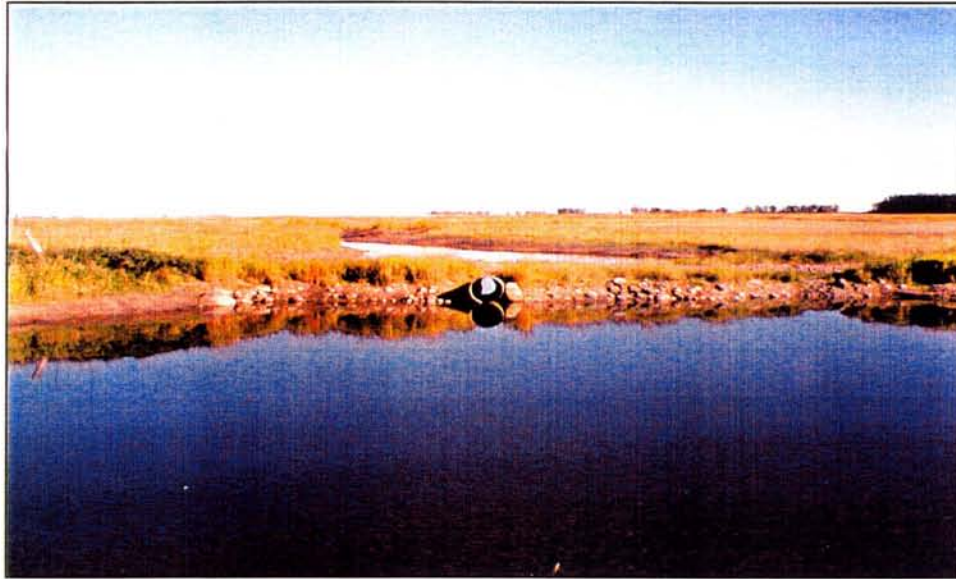
M10 Downstream side of one 36" CMP, in good condition, 0.1 foot of water (10-1-98), Section 14 & 23, T158N, R66W, N 550470.00, E 2332618.64, Elevation 1459.0 @ invert of CMP.

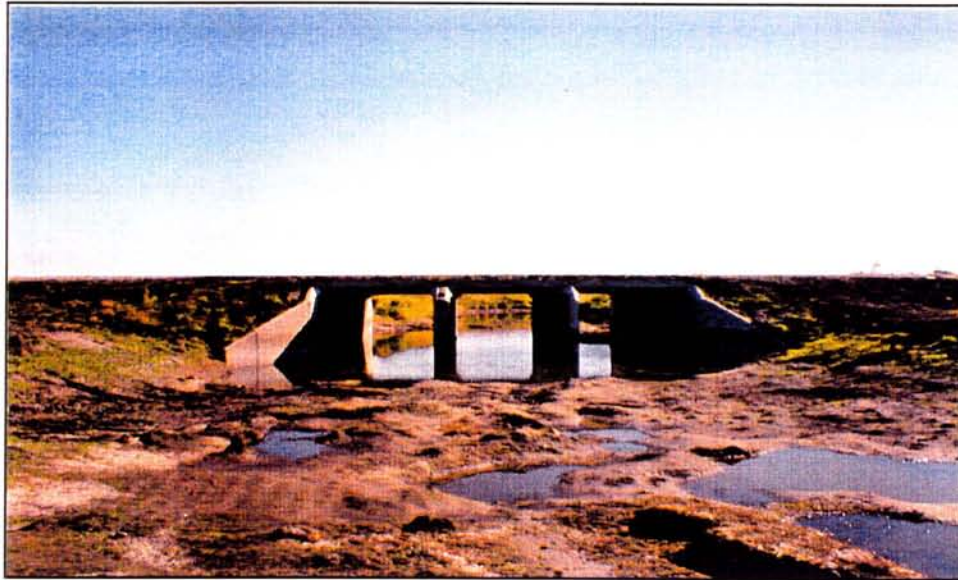
M11 Upstream side of 3 cell 10.5' high box culvert, in new condition, 1.5 feet of water (10-1-98), Section 10 & 11, T158N, R66W, N 556413.54, E 2328612.24, Elevation 1460.7 @ ∇ of coulee.

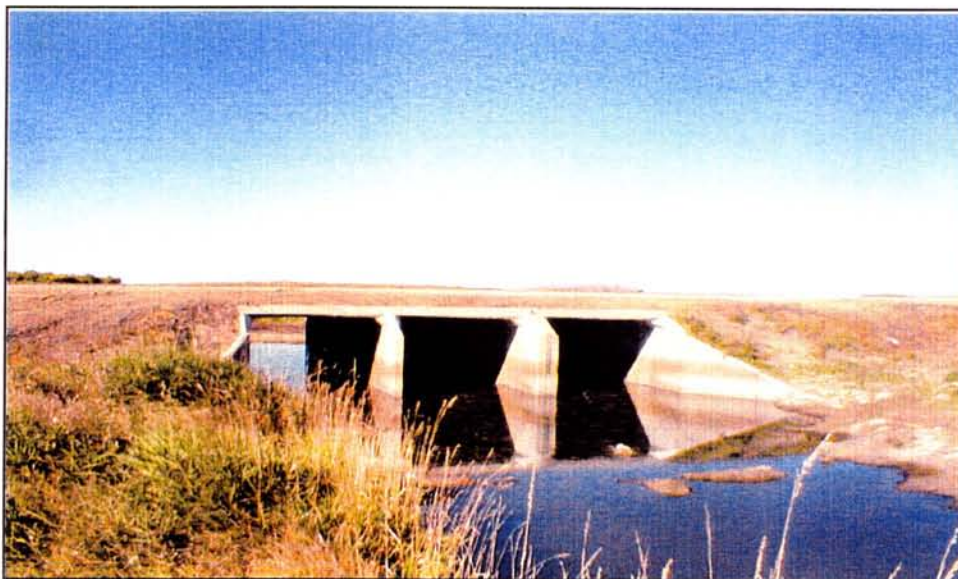
M11 Downstream side of 3 cell 10.5' high box culvert, in new condition, 2.0 feet of water (10-1-98), Section 10 & 11, T158N, R66W, N 556414.07, E 2328665.90, Elevation 1460.2 @ ∇ of coulee.

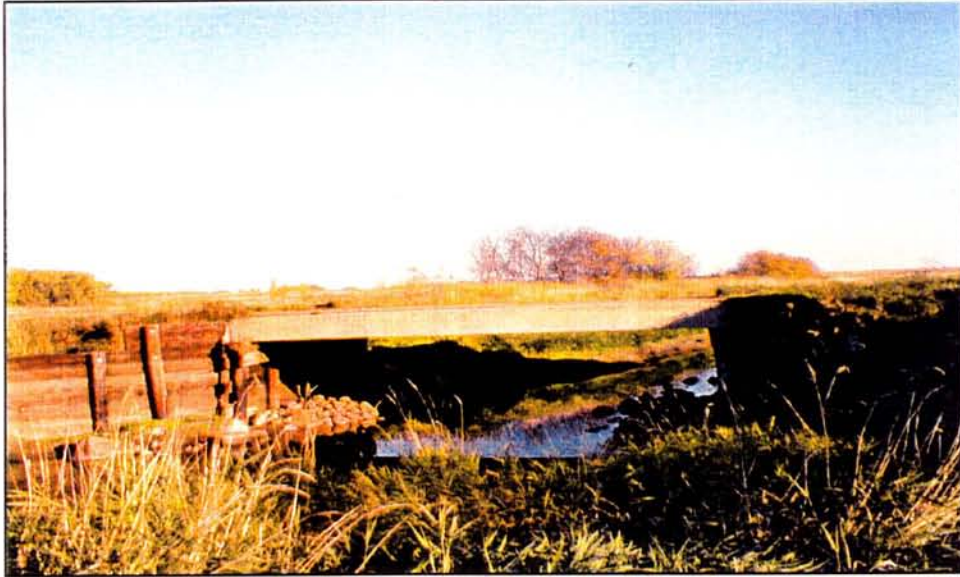
M12 Downstream side of concrete & wood bridge, in fair condition, 3.5 feet of water (10-2-98), Section 9, T158N, R66W, N 559009.79, E 2319970.89, Elevation 1464.5 @ Φ of coulee.

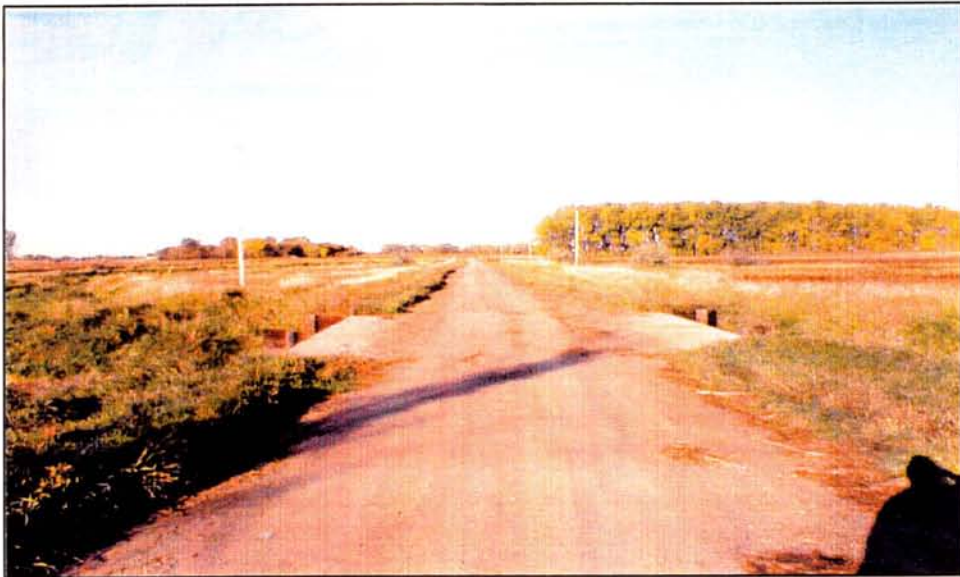
M12 Center of concrete & wood bridge, looking west, in fair condition, 24 feet wide & 34 feet long, Section 9, T158N, R66W, N 558997.87, E 2319970.95, Elevation 1477.7 @ center of bridge.

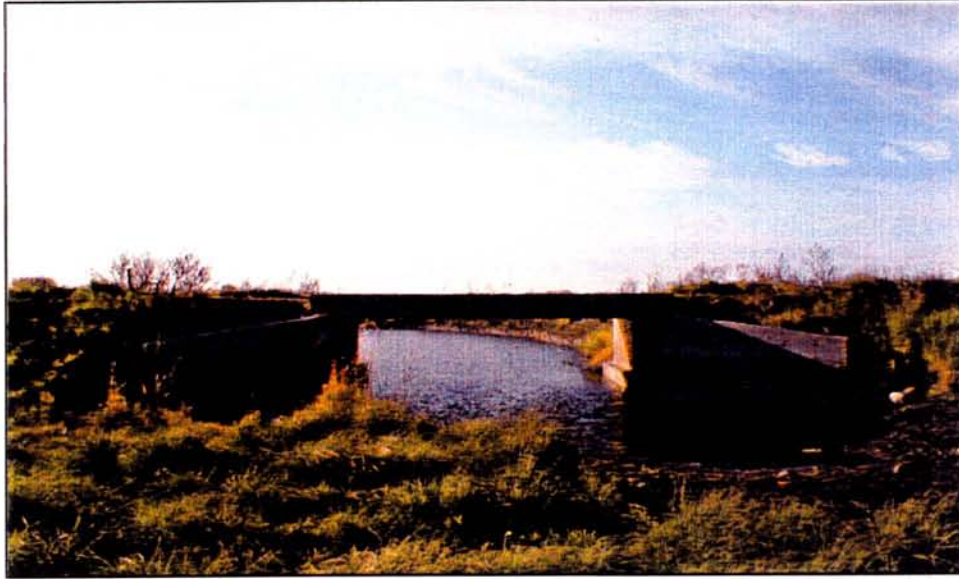
M13 Upstream side of concrete bridge, in poor condition, 2.8 feet of water (10-2-98), Section 33 & 4, T158 & 159N, R66W, N 566166.44, E 2322347.49, Elevation 1469.1 @ ∇ of coulee.

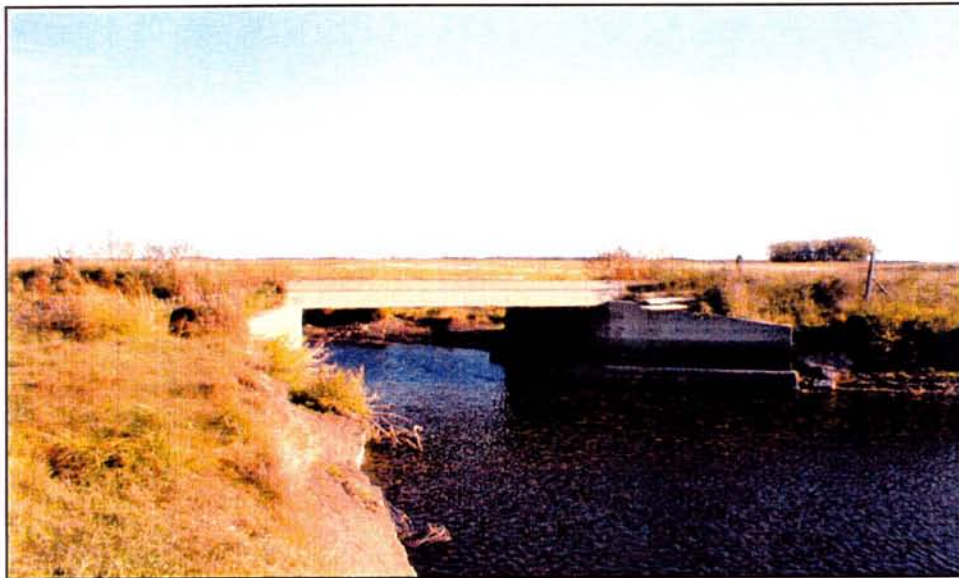
M13 Downstream side of concrete bridge, in poor condition, 4.7 feet of water (10-2-98), Section 33 & 4, T158 & 159N, R66W, N 566147.22, E 2322348.38, Elevation 1467.2 @ ∇ of coulee.

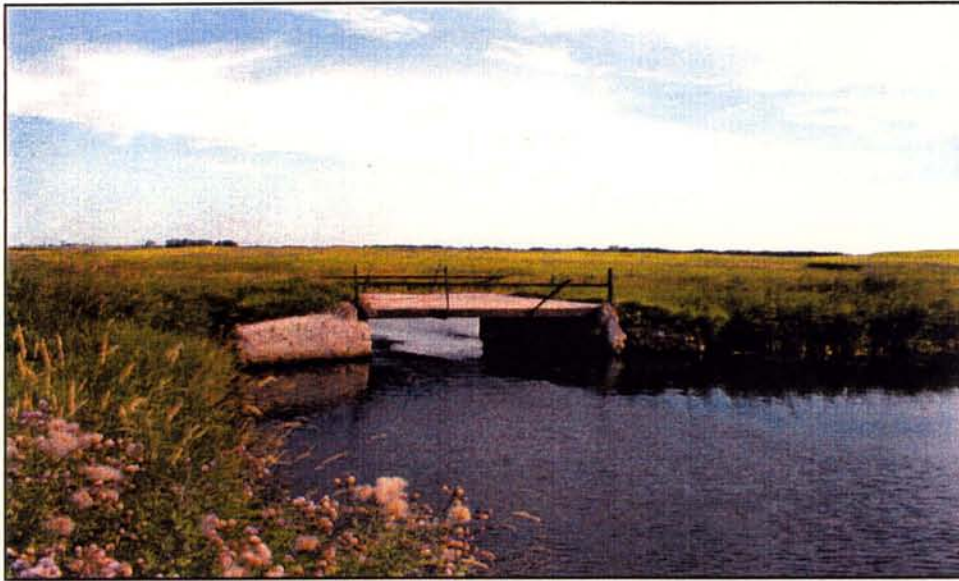
M16 Downstream side of concrete bridge, in poor condition, 6.1 feet of water (7-30-99), Section 21 & 28, T159N, R66W, N 576714.72, E 2322662.97, Elevation 1467.7 @ ∇ of coulee.

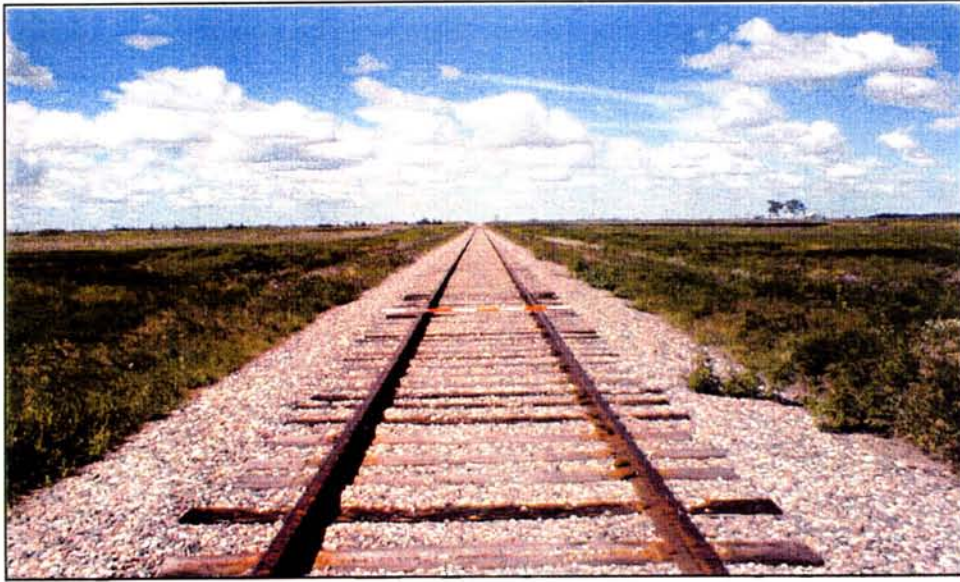
M23 Center of railroad crossing of four 60" concrete pipes, in fair condition, looking west, Section 5, T159N, R66W, N 597271.50, E 2314315.91, Elevation 1509.9 @ ∇ of railroad.

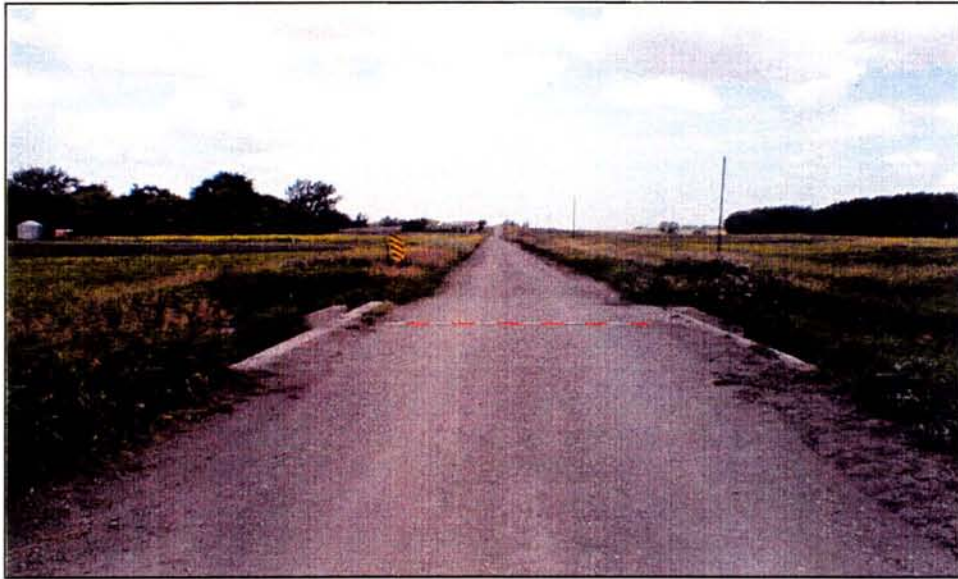
B1 Center of concrete bridge, in fair condition, looking north, 18 feet wide, 31.5 feet long, Section 8 & 9, T158N, R66W, N557634.79, E 2318060.19, Elevation 1476.7 @ center of bridge and gravel road.

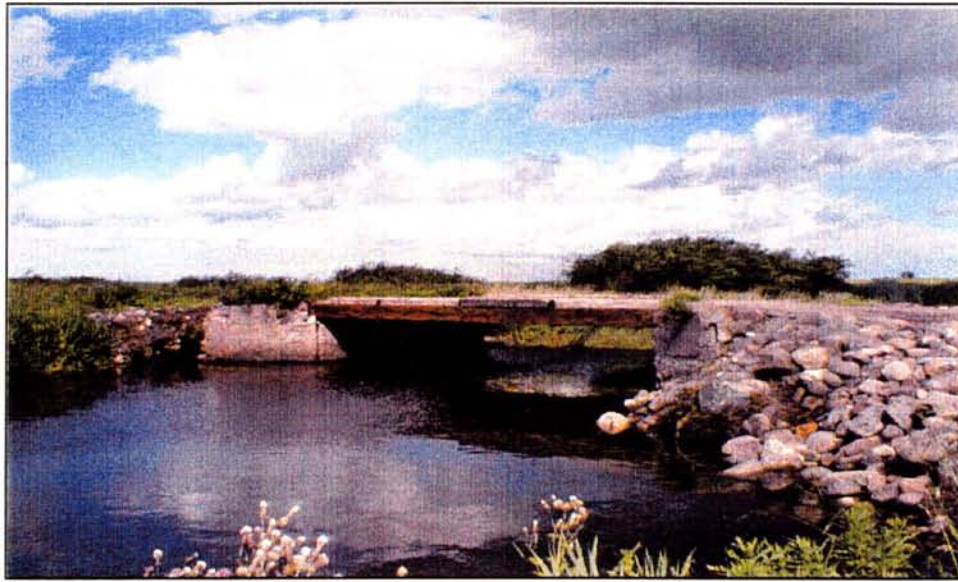
B5 Upstream side of concrete bridge, in fair condition, 7.5 feet of water (8-17-99), Section 23 & 24, T159N, R67W, N 580040.10, E 2301747.29, Elevation 1497.8 @ center of concrete bridge.

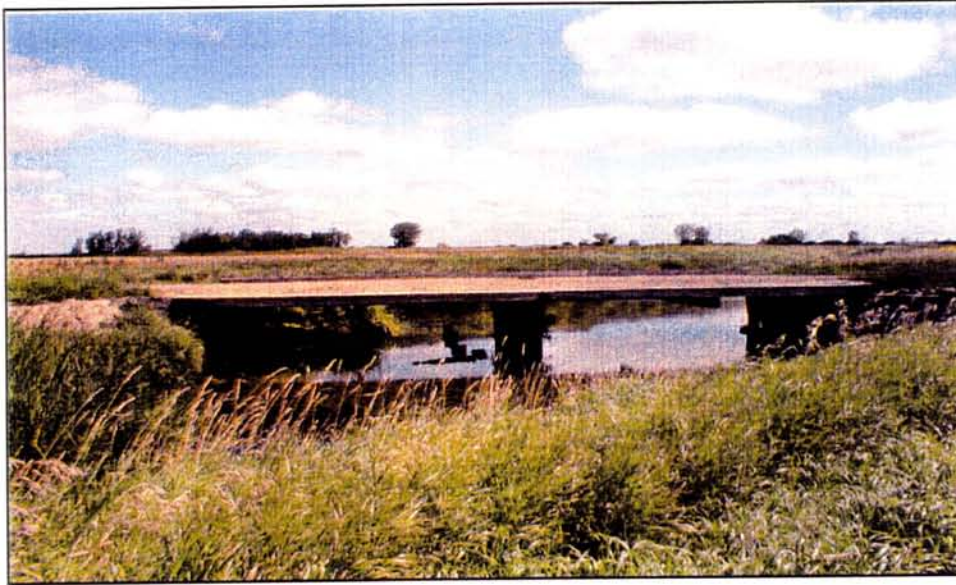
B7 Upstream side of wood & concrete bridge, in fair condition, 4.1 feet of water (8-18-99), Section 15 & 16, T159N, R67W, N 584162.61, E 2291103.93, Elevation 1514.8 @ ∇ of coulee.

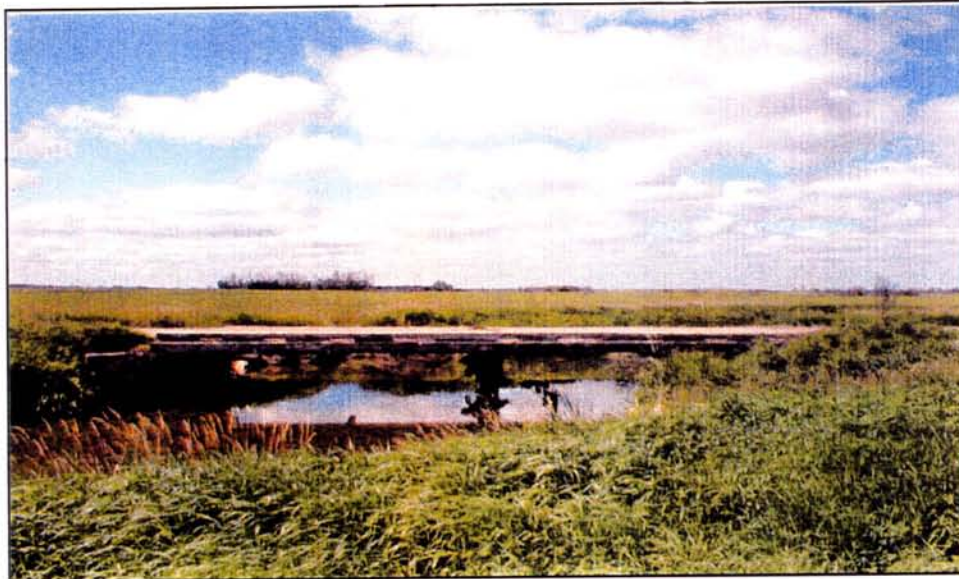
B7 Downstream side of wood & concrete bridge, in fair condition, 3.9 feet of water (8-18-99), Section 15 & 16, T159N, R67W, N 584153.05, E 2291131.18, Elevation 1515.1 @ ∇ of coulee.

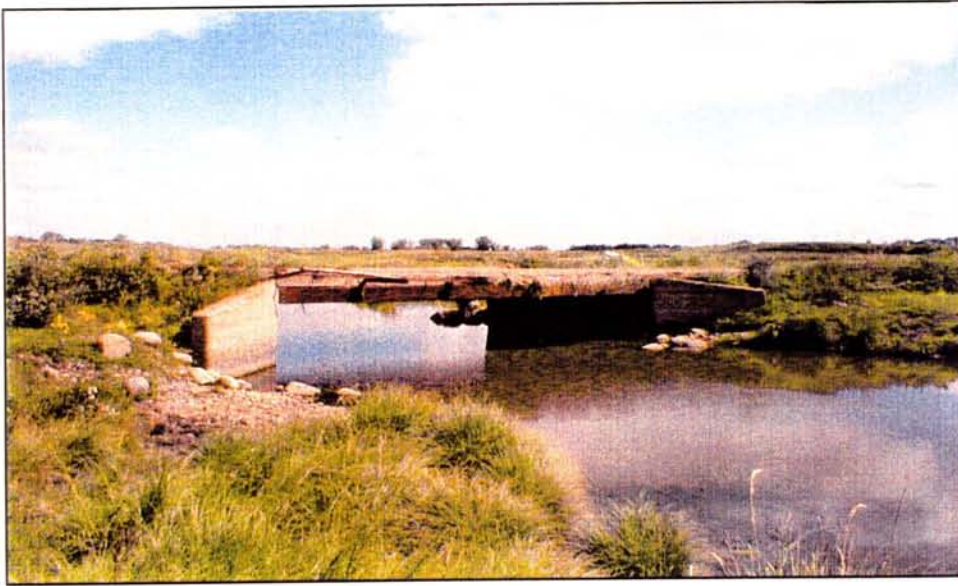
B9 Upstream side of concrete bridge, in poor condition, 2.8 feet of water, (8-18-99), Section 7 & 8, T159N, R67W, N 591588.03, E 2280413.43, Elevation 1533.6 @ Φ of coulee.

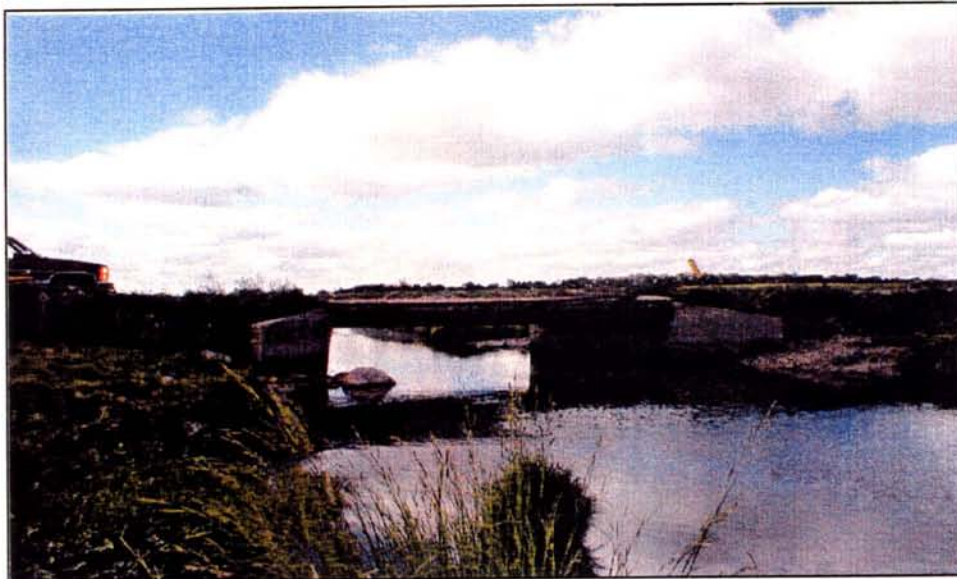
B9 Downstream side of concrete bridge, in poor condition, 3.1 feet of water, (8-18-99), Section 7 & 8, T159N, R67W, N 591586.75, E 2280432.99, Elevation 1533.2 @ Φ of coulee.

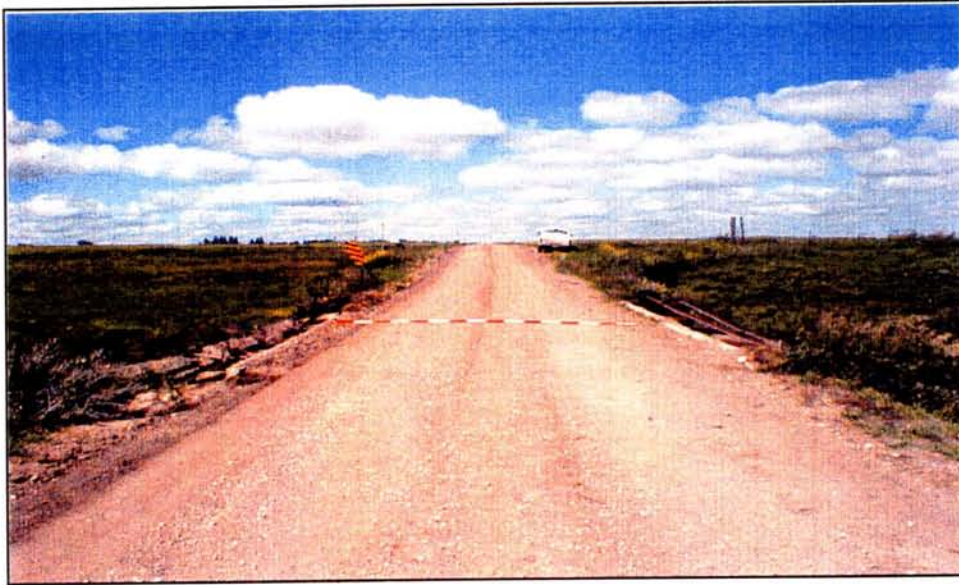
B9 Center of bridge in poor condition, looking north, 19.0' wide & 36.0' long, Section 7 & 8, T159N, R67W, N 591588.30, E 2280423.14, Elevation 1543.0 @ center of bridge, top of gravel.

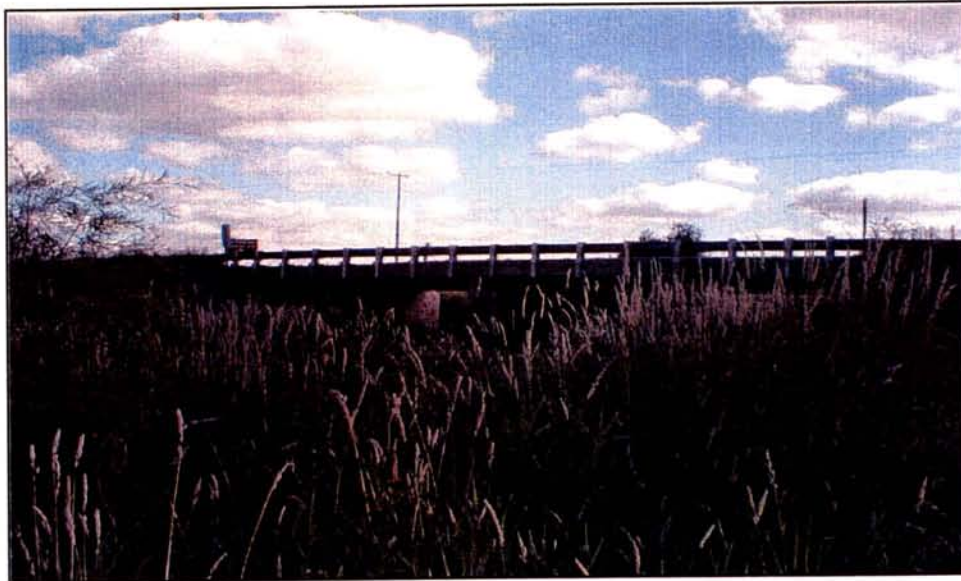
B10 Upstream side of concrete bridge, in good condition, on N.D. Hwy. 66, 1.2 feet of water, (8-18-99), Section 31 & 6, T159 & 160N, R67W, N 597191.08, E 2275762.21, Elevation 1546.0 @ Φ of coulee.

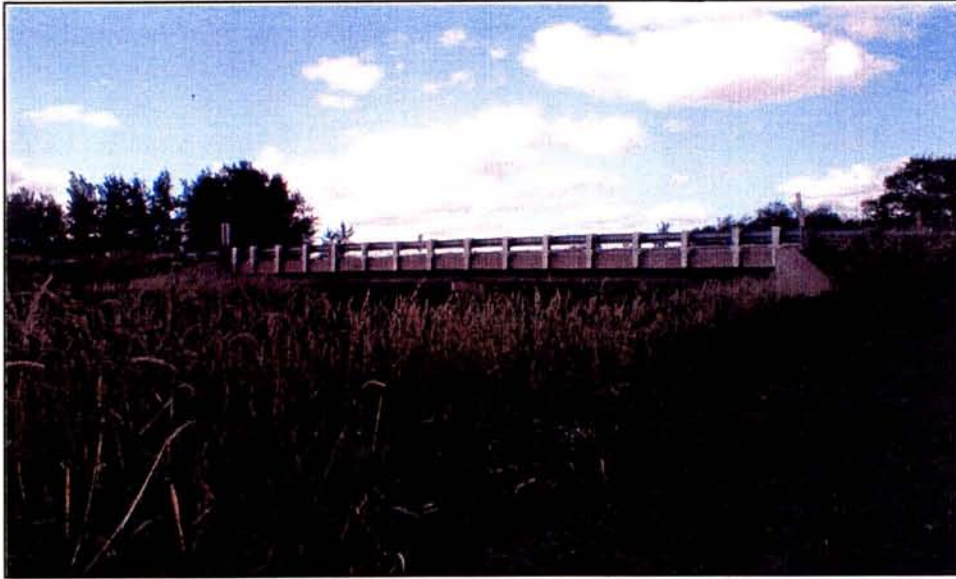
B10 Downstream side of concrete bridge, in good condition, on N.D. Hwy. 66, 1.7 feet of water, (8-18-99), Section 31 & 6, T159 & 160N, R67W, N 597159.42, E 2275795.79, Elevation 1545.5 @ ∇ of coulee.

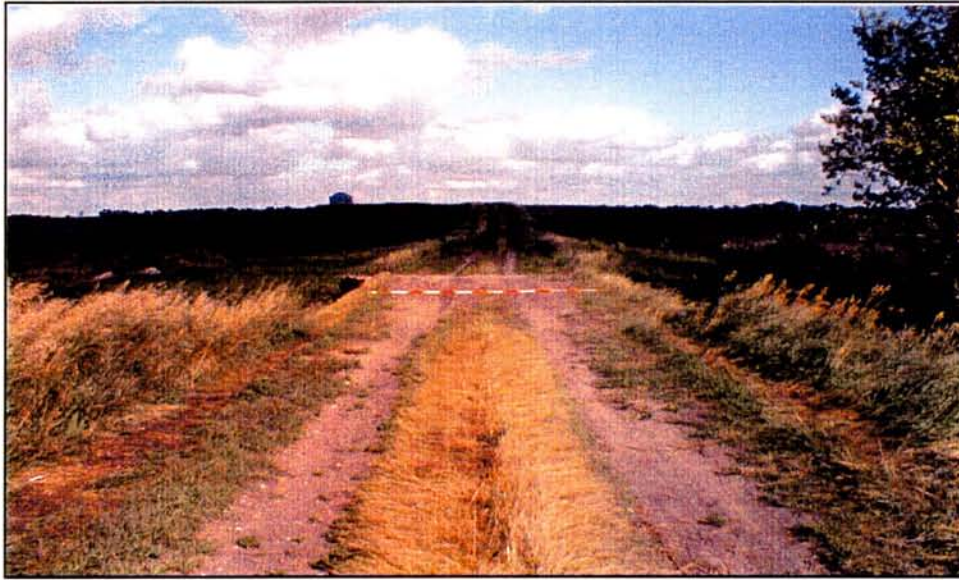
B19 Center of bridge looking east, in fair condition, 17.7' wide & 48.0' long, N 649683.44, E 2256206.39, Elevation 1698.7 @ center of bridge, top of gravel.
